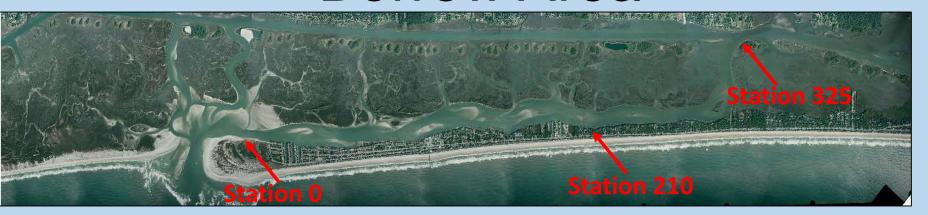
## **Borrow Area**

- Borrow area volume is 1,779,200 cubic yards
  - Banks Side Channel 1: 26,400 cubic yards
  - Banks Side Channel 2: 30,300 cubic yards
  - Banks Channel Station 210 to 0: 1,100,000 cubic yards
  - Banks Channel Station 210 to 325: 622,500 cubic yards

Location	Mean (mm)	% of Calcium Carbonate
Banks Side Channel 1	0.26	10.73
Banks Side Channel 2	0.33	13.6
Banks Channel Station 210 to 0	0.37	19.3
Banks Channel Station 210 to 325	0.29	13.6
Native	0.25	6.6

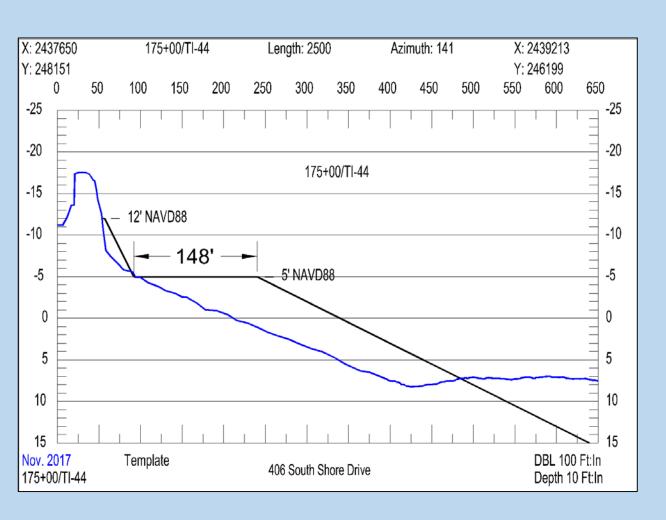
### TI Coastal Design – Option 1

#### **Project Parameters**

Berm 145' wide @ 5' NAVD

**Dune Face Dressed**

1:5 Dune Slope

1:20 Beach Slope

2 Million CY Beachfill from Back Channel System
